Subject: **KENNETH HAHN HALL OF ADMINISTRATION
ROOF REPLACEMENT PROJECT
MONTHLY UPDATE - SEPTEMBER**

KENNETH HAHN HALL OF ADMINISTRATION – ROOF REPLACEMENT 2014

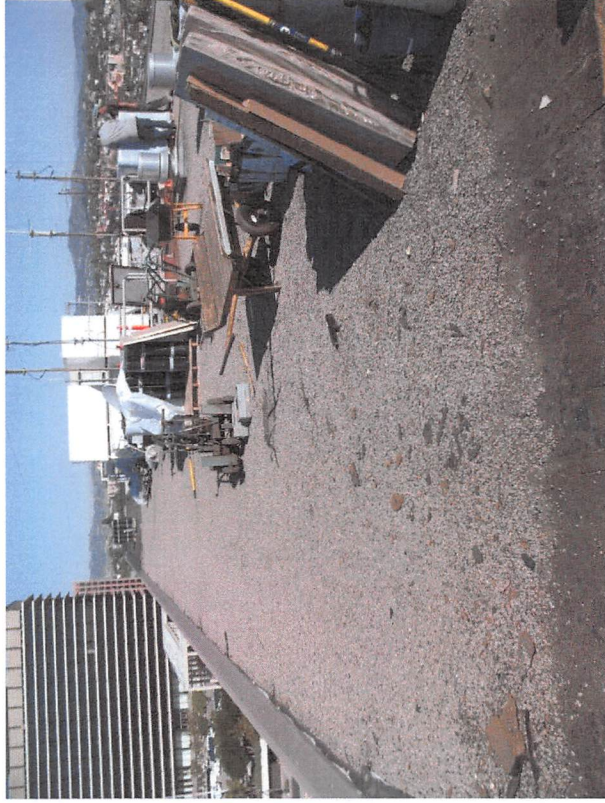
Above: The original roof - Gravel over a built-up roll membrane.

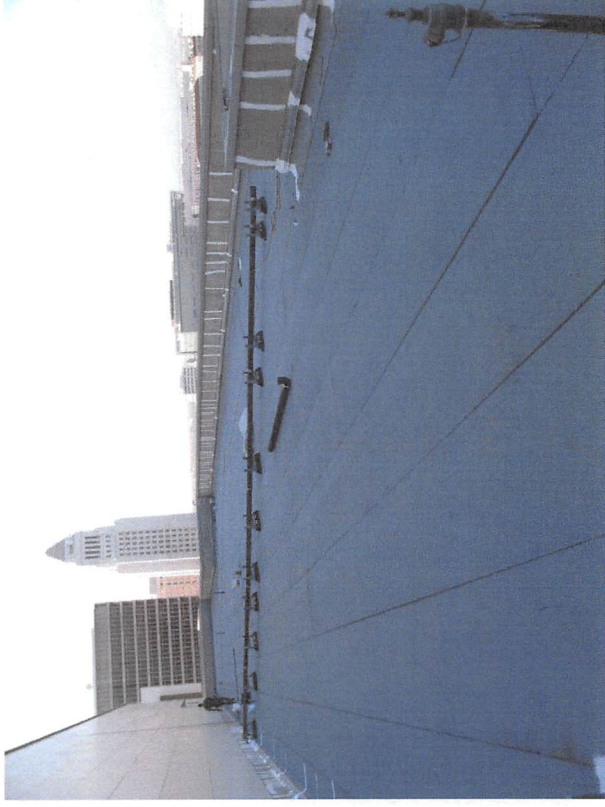
Above: New roll membrane layer, over a 1^{1/2}" layer of insulation

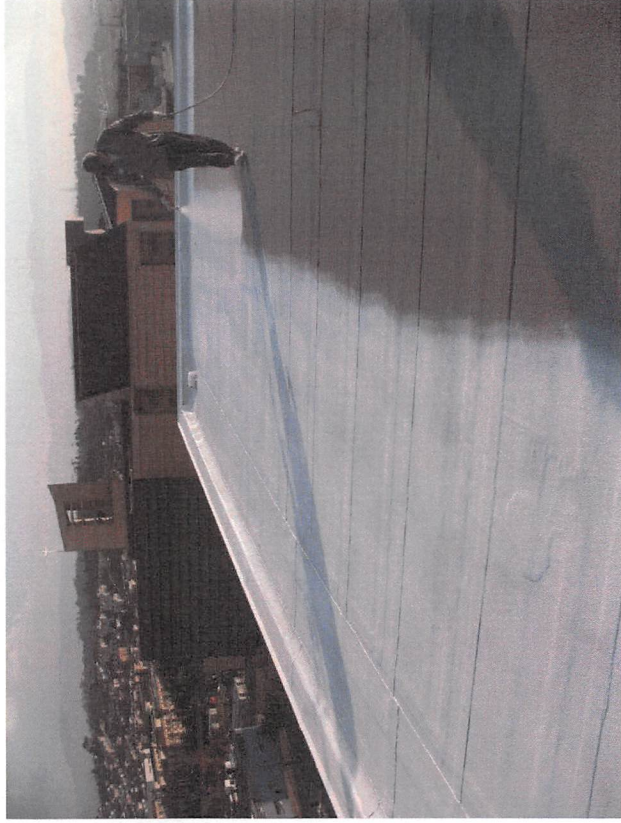
Above: Application of cool roof bright white coating over finished roof

Just as wearing light-colored clothing can help keep you cool on a sunny day, cool roofs use solar-reflective surfaces to maintain lower roof temperatures. Standard or dark roofs can reach temperatures of 150°F or more in the summer sun. A cool roof under the same conditions could stay more than 50°F cooler. Lower roof temperature will extend roof service life. A cool roof can also benefit a building and its occupants by reducing energy bills through decreased air conditioning needs.

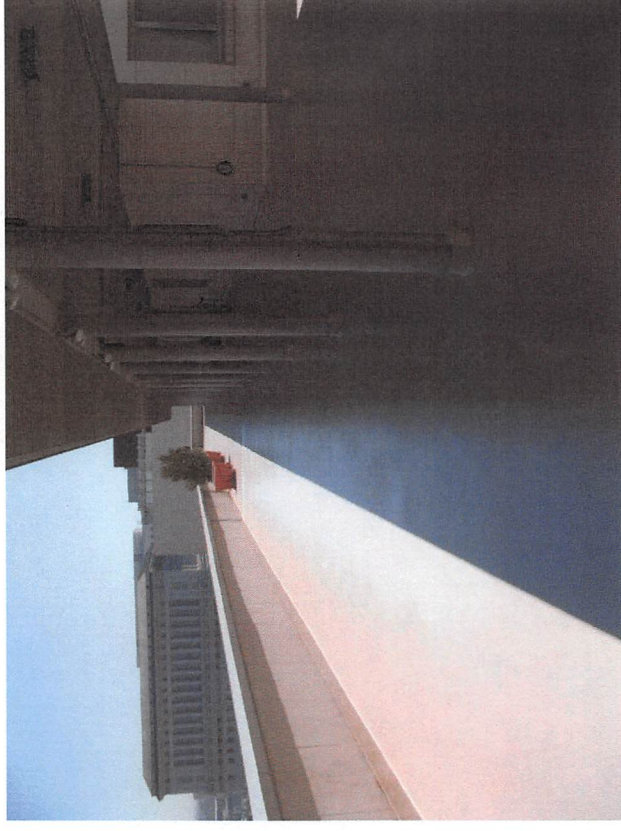
Below: Finished walking deck surface

- Sanding, repairs, epoxy, paint, and sealer was completed on the south and west sides of the walking deck.
- The 2nd coat of sealer was applied to the north side of the walking deck.
- Walking decks were pressure-washed to remove all dirt and debris.
- Detail and touch up was completed on all of the walking decks.
- Entire job site was cleaned up.
